RE: Site Inspection, Energy Fuels Nuclear, Repete & Lee Mine, M/037/038, (BLM UTU-SJ-93-02), San Juan County, Utah

Purpose of Inspection: To examine the reclamation stability of the site

M037038.ins

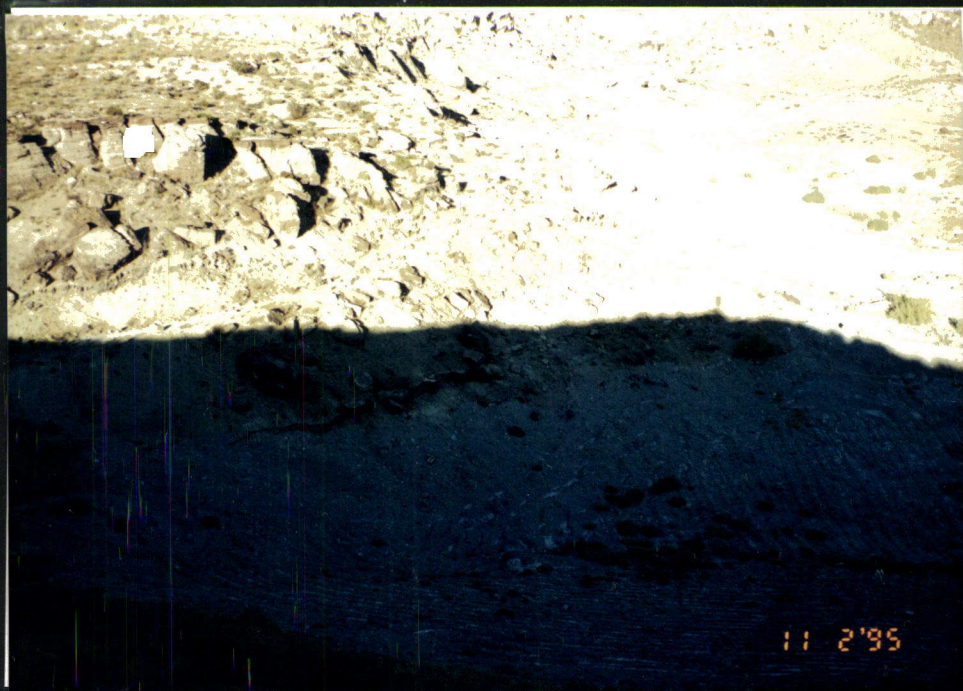
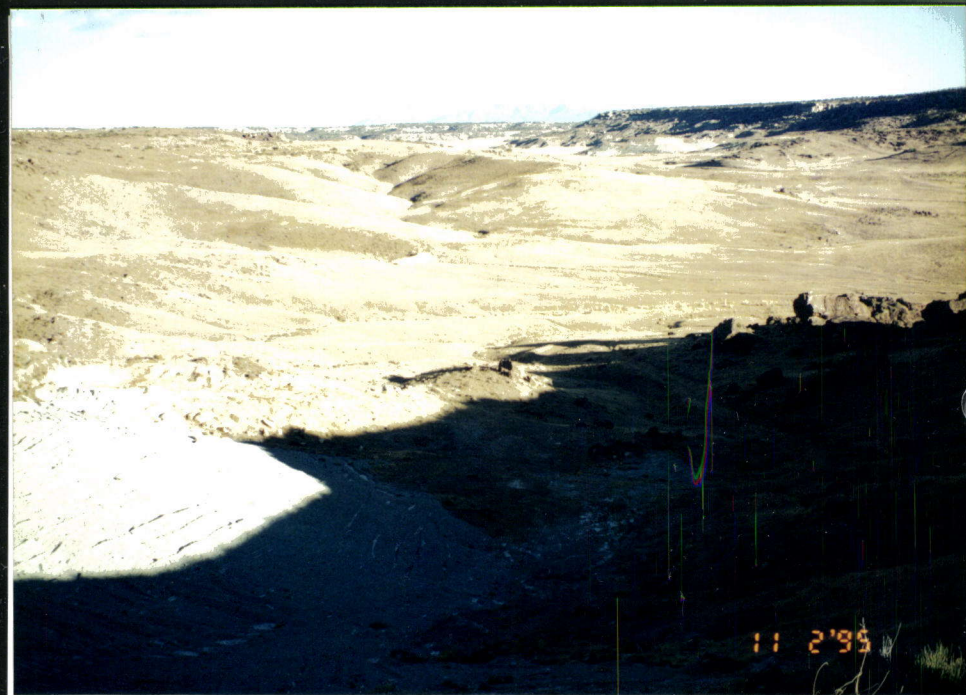
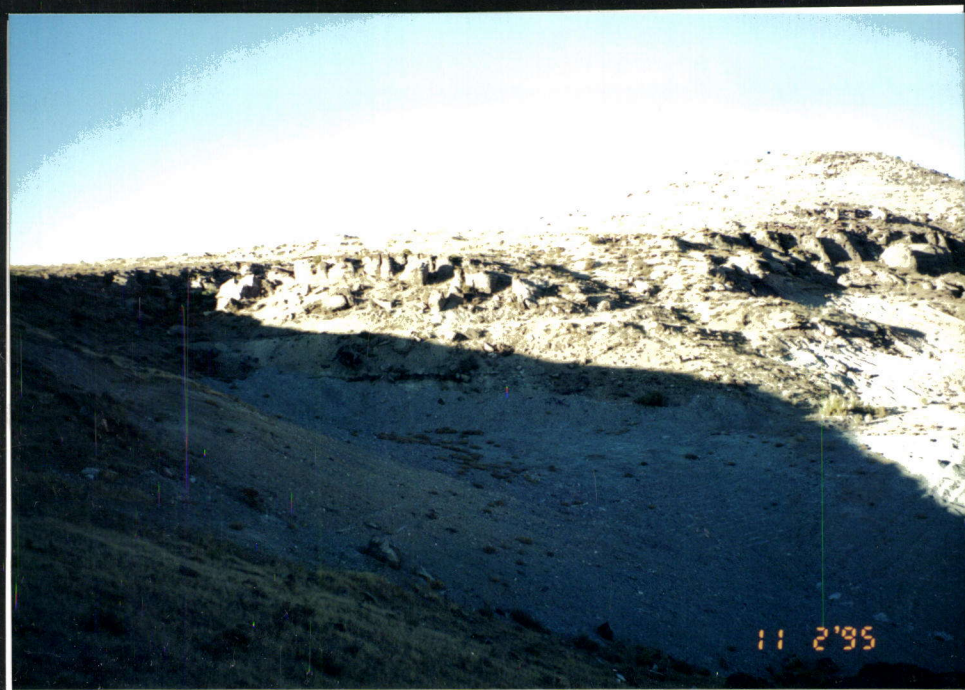
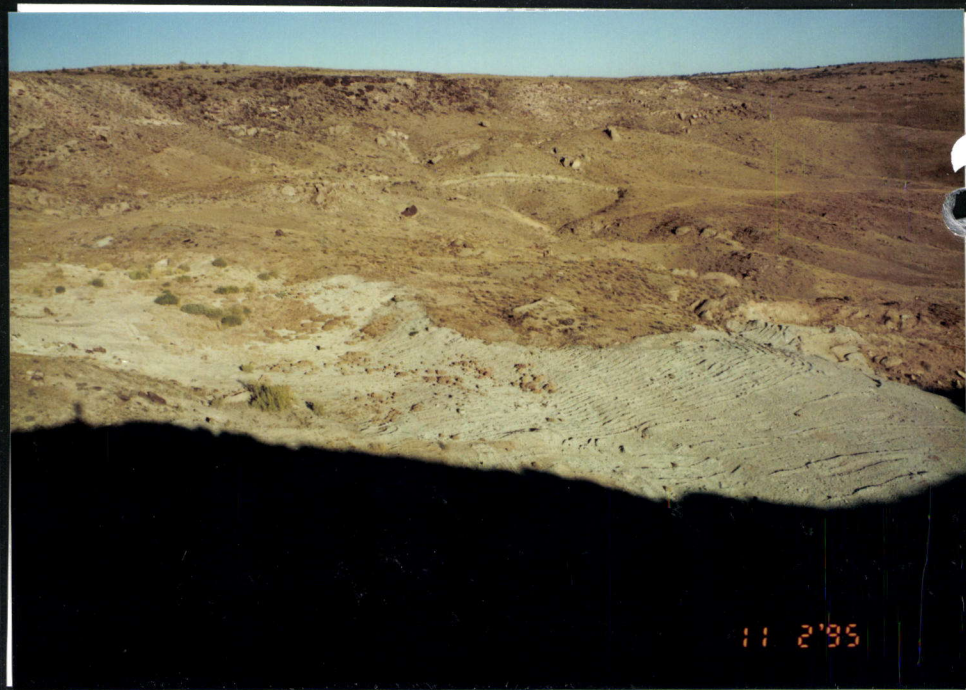
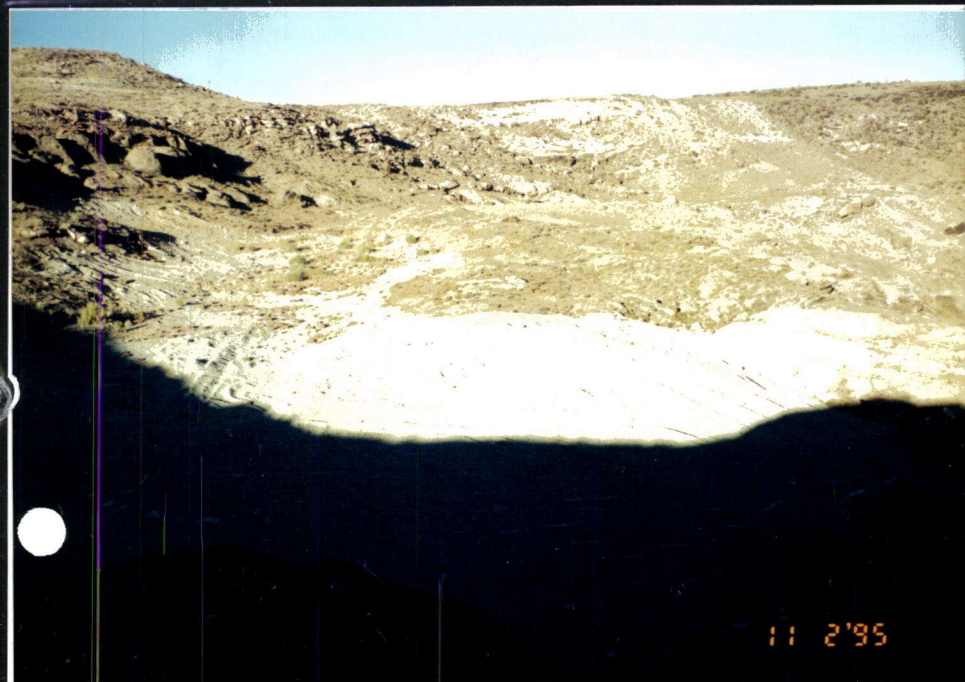
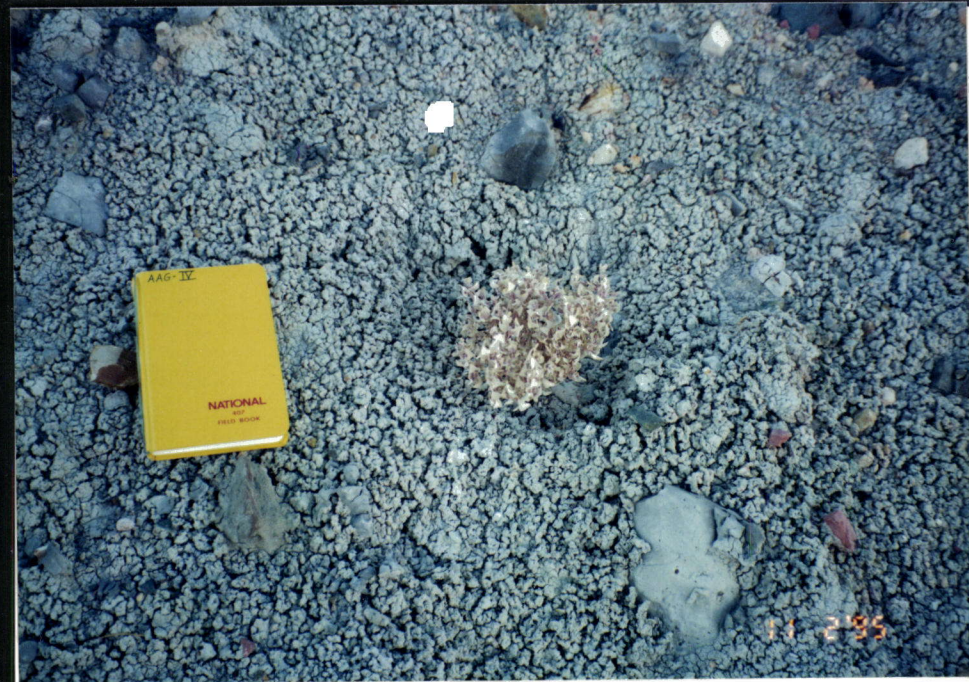
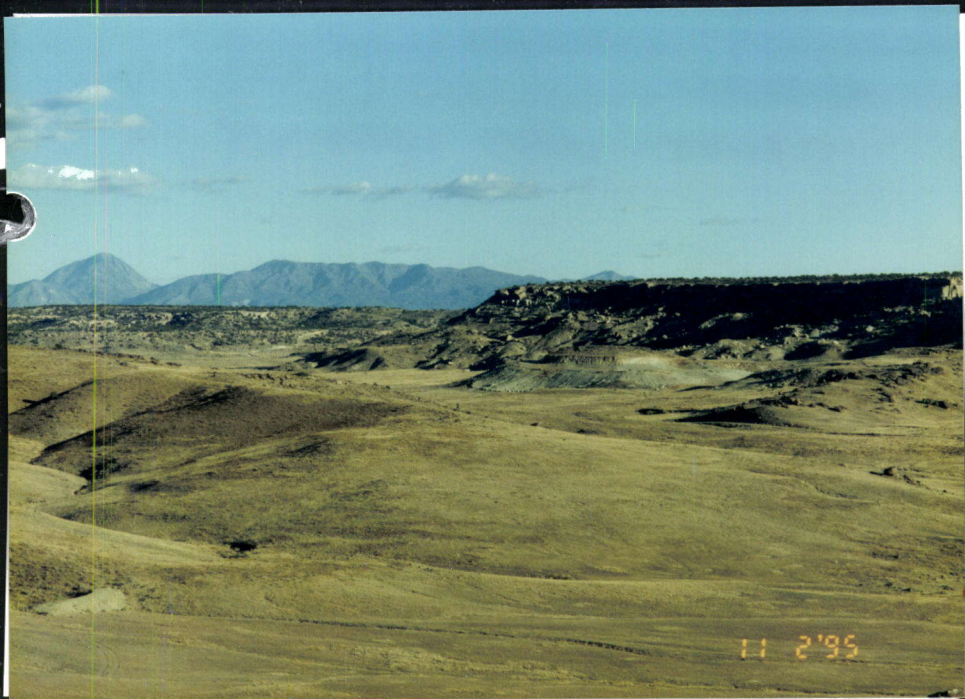
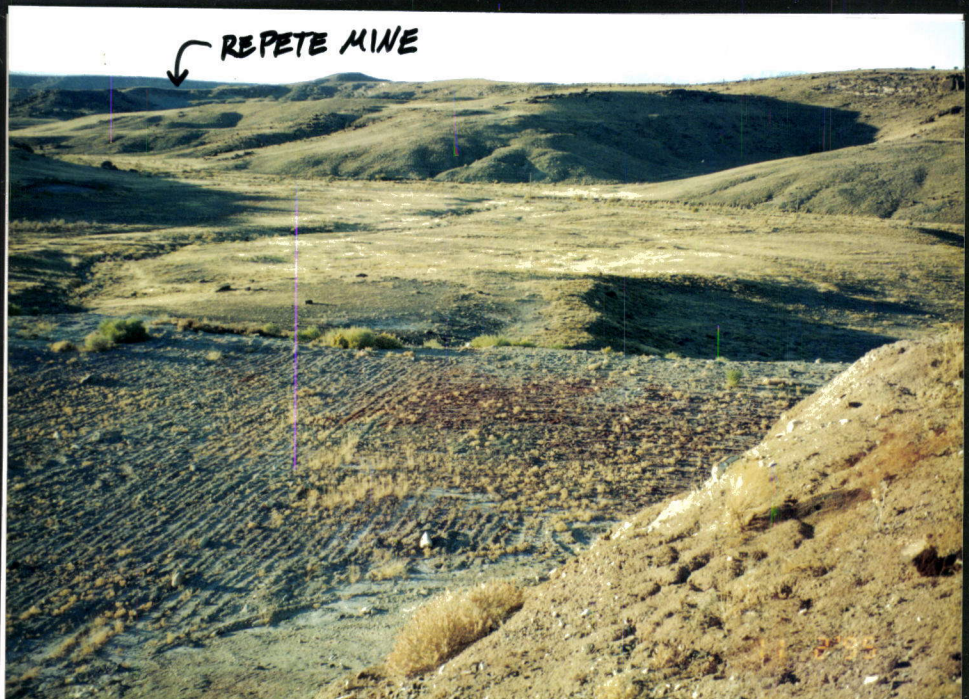
REPORT 4 LEE

The Lee site was next visited. The Lee site is about one mile east from the Repete site. The revegetation success at the Lee site is better when compared to the Repete site. Here again, the gray soils are a poor growth medium and appear to have a large amount of clay. Portions of the Lee site were

furrowed or roughened along the contour to improve water retention and minimize erosion. Portions of the regraded slopes were regraded by pushing down the gradient, probably due to the steepness of these areas. The revegetation success is better in the areas which were furrowed along the contour or had some other type of surface roughness created.

Photographs were taken of the mine site from different vantage points. The road to this mine site is entirely reclaimed. It appears that someone has attempted to drive on the reclaimed access road for a short distance off the main road; however, they didn't get very far before having to turn around.

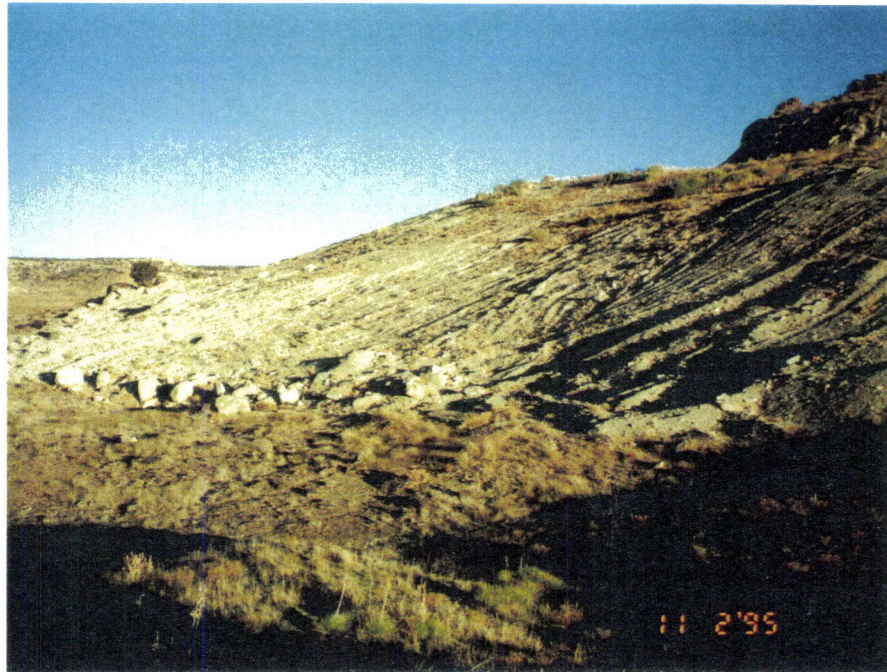
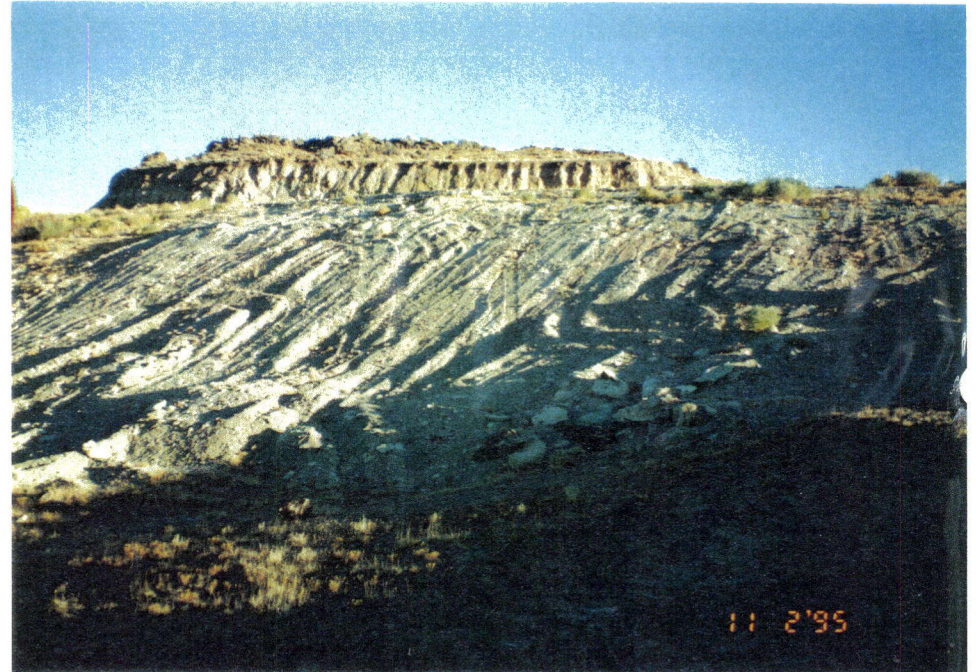
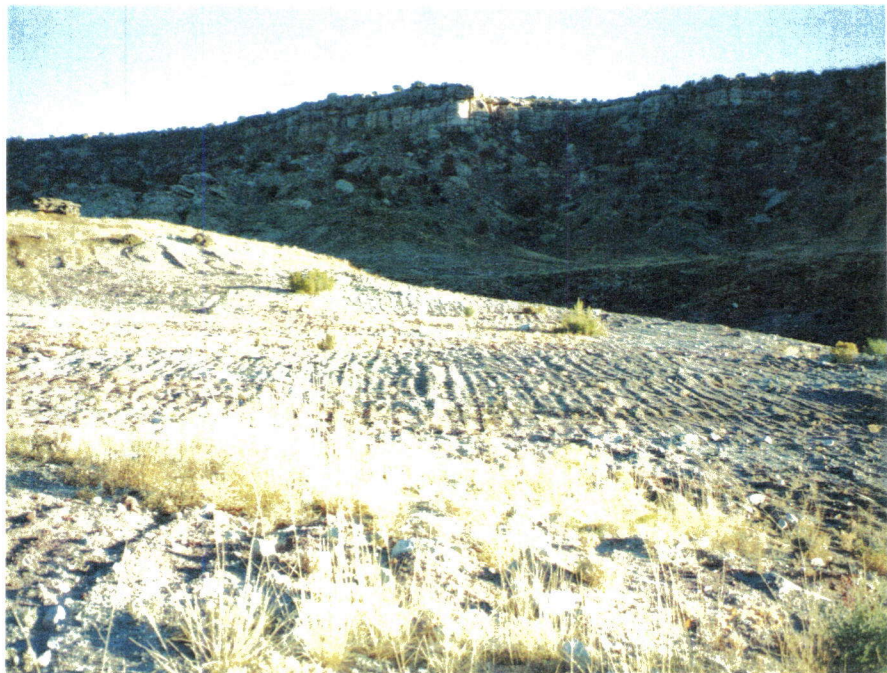
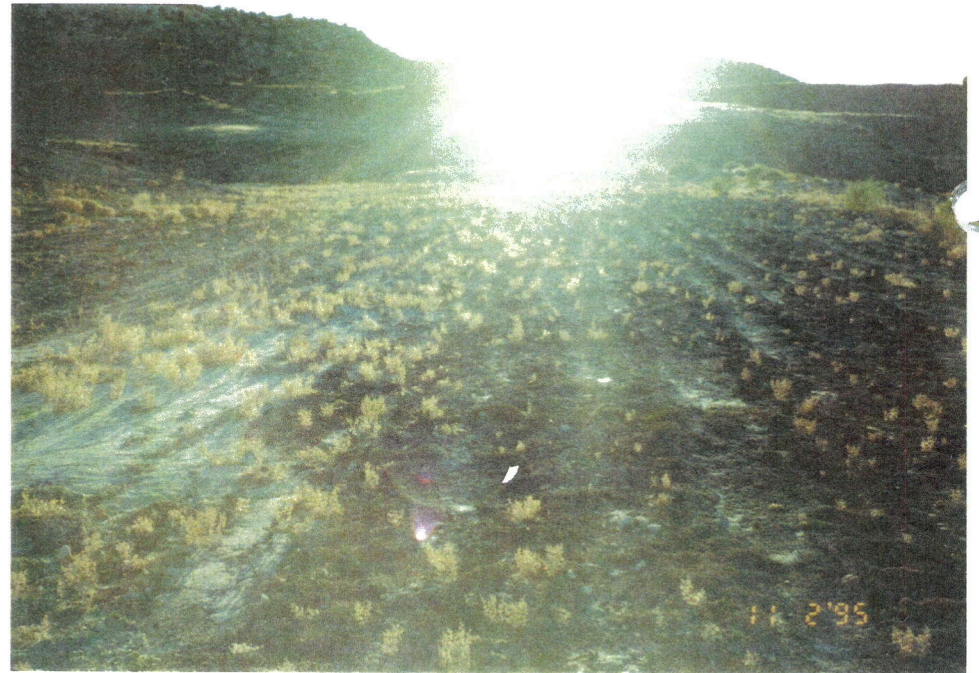
11/02/00  
REPETE & LEE

The Repete Mine site was visited first. A closer review of the files back in the office revealed this portion of the site was known as the Repete Mine Adit #2 area. Photographs were taken of this portion of the site looking down towards the north and northeast. The Lee site, which is also associated with this permit, is visible in the distance from this site.

Vegetation growing on the reclaimed portions of the Adit #2 area is very minimal. The poor revegetation success here may be attributed to the soils in this area. Closer examination of the soils reveal a large amount of clay is present. This site was initially disturbed prior to the Act, so no topsoil material was salvaged for use in reclamation. The reclaimed areas show furrowing along the contour which should improve the water retention and revegetation efforts. There are no mine portals currently evident or visible at the site.
